Honeysuckle Reservoir decommissioning

Christopher Dwyer

Earth Tech, PO Box 165 Wangaratta, 3676. Web: www.earthtech.com.au, Email: chris.dwyer@earthtech.com.au

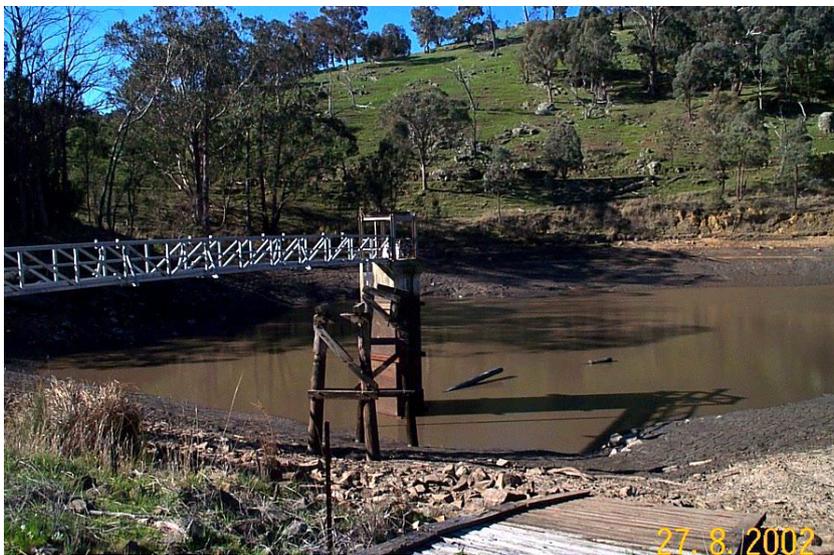
Figure 2. Honeysuckle Reservoir prior to decommissioning.

The next stage of the project was to remove the unsafe structure, and in the process ensure sediment in the base of the reservoir (Figure 2) did not pose a major risk to the local environment, or those downstream of the site.

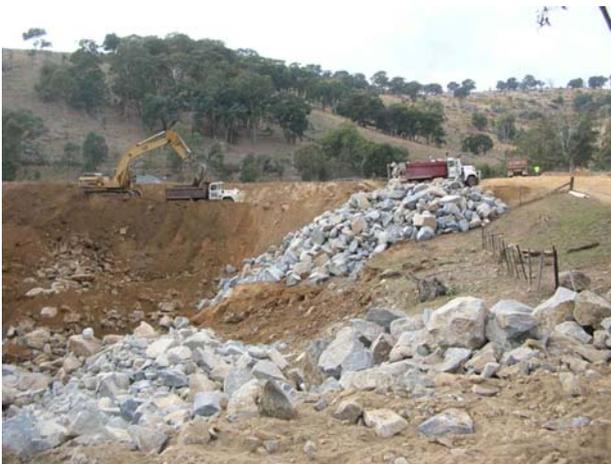
Figure 3. Commencing the embankment removal

Construction works proceeded largely without issue. The material in the embankment was relocated on site to a stockpile above the 100 year ARI flood level. The main challenge was to remove the embankment (Figure 3), while maintaining flows down Honeysuckle Creek. Given the large catchment area and the propensity of the site to flooding and water logging, a five day window of opportunity with dry weather was found when the embankment was breached, with flows then allowed to pass over the main chute (Figure 4).

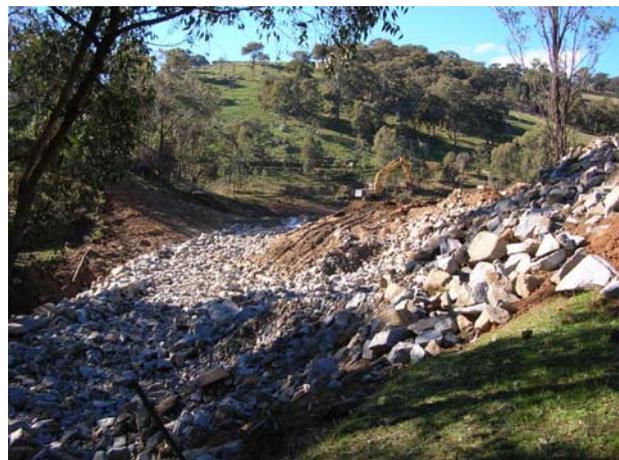
Figure 4. Embankment with initial breach in place

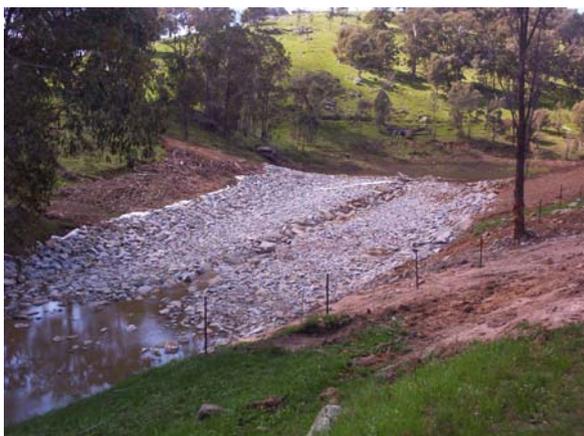
Figure 5. Main chute with completed fishway.

A rock fishway was incorporated into the main chute to facilitate fish passage upstream. The chute consists of continuous “vee” shaped arrangements down the fishway. Each vee diverts flow to the outside of the channel, reducing velocity and creating resting pools. The fishway is approximately 100m in length, and drops 6m; it provides a number of resting points, low velocity zones and on average approximately 30cm depth of flow. As such the fishway is designed to provide passage for both large and small bodied fish.

- Localised improvement in fish passage (a barrier remains downstream) (Figure 5).
- Localised improvement in riparian vegetation via revegetation (poor riparian vegetation exists upstream and downstream of the site) (Figure 6).
- Improved platypus habitat via more consistent water levels (Centre for Environmental Management University of Ballarat, 2004).

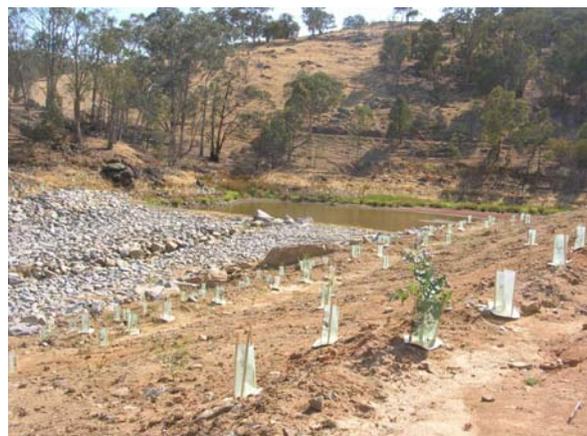
Figure 6. Revegetation 2007.

The site was revegetated, with wetland planting a feature around the low level pool. The construction of the main chute necessitated the removal of several mature native trees. The revegetation of the site provides adequate vegetation Net Gain to compensate these losses.
