# Waterway rehabilitation – Shays Creek

**Luke Austin**

Wimmera CMA, PO Box 479, Horsham VIC 3402. Web: [www.wcma.vic.gov.au](http://www.wcma.vic.gov.au), Email: [austinl@wcma.vic.gov.au](mailto:austinl@wcma.vic.gov.au)

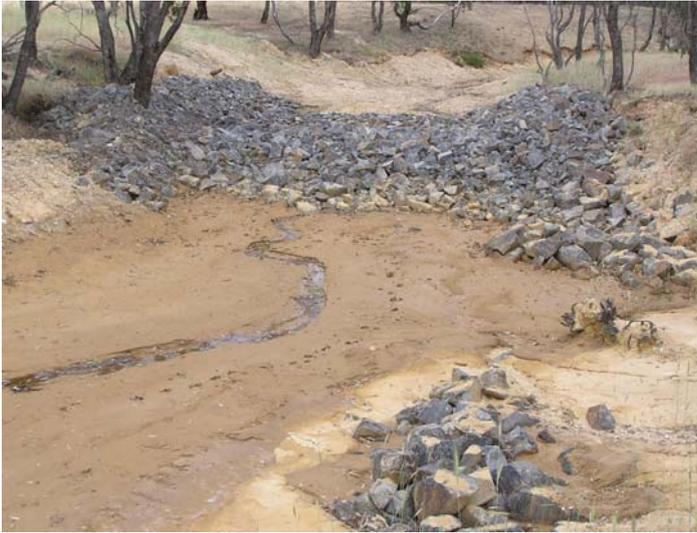
**Figure 3. Evidence of sediment build up and storage on upstream side of existing rock chute.**

Over the last 18 months, Wimmera CMA has worked closely with local landholders to develop and implement a whole of system strategy to address the problem of sediment generation and transportation in Shays Creek. The aim of the works is to control the bed grade allowing for sediment to be stored in the creek (Figure 3). Whilst addressing bank erosion through rock groynes and managing overland flows. The works are being implemented in stages, with a series of rock chutes, entry points and rock groynes already completed and showing a significant reduction in the sediment load reaching the Wimmera River.

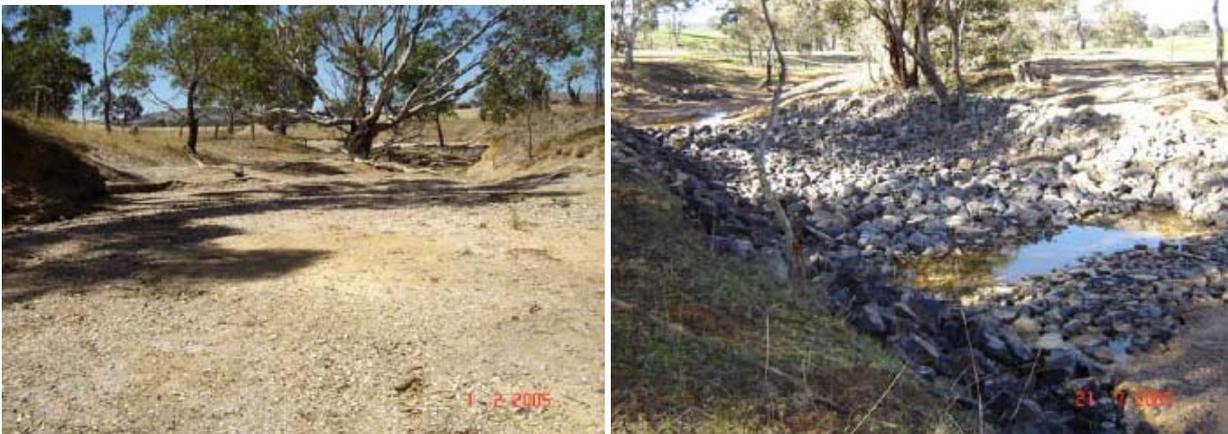
**Figure 4. Before and after – 'Elevated Crest' rock chute.**

Works focused on stabilising the bed and banks limiting the undercutting process and subsequent bank failure. A stable grade was achieved by constructing a four 'elevated crest' rock chutes, dropping a total of 4.5m head. These structures will act as a low lying instream obstruction allowing low flows to pass through causing backwaters to pond and slow behind them enabling sediment to drop out. In larger flow events the ponded water will overtop these structures allowing them to act as a standard rock chute. Stabilisation of the banks was achieved through a series of rock groyne structures being constructed deflecting flows away from the toe of the banks.

Summary of structures constructed over the 1km length of the works (Figures 4 and 5 (SKM, 2006)):

- 4 elevated crest porous drop structures;
- 5 re-entry structures for lateral flow re-entry;
- Numerous rock groyne structures;
- Bank protection works at high energy location;
- Redistribution of sediments forming a new low flow channel and encouraging toe of bank infill and instream vegetation;

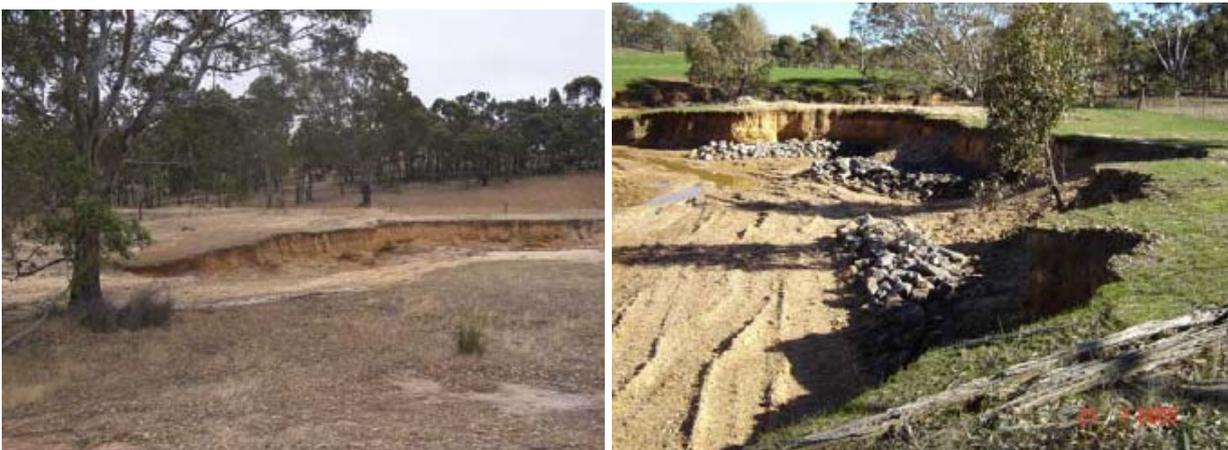
**Figure 5. Before and after – rock groynes.**
