Valley chokes in the upper Wimmera River catchment are playing key roles in mitigating the threats of erosion – a model case study

Martin Hillemacher¹ and Brian S. Seymour²

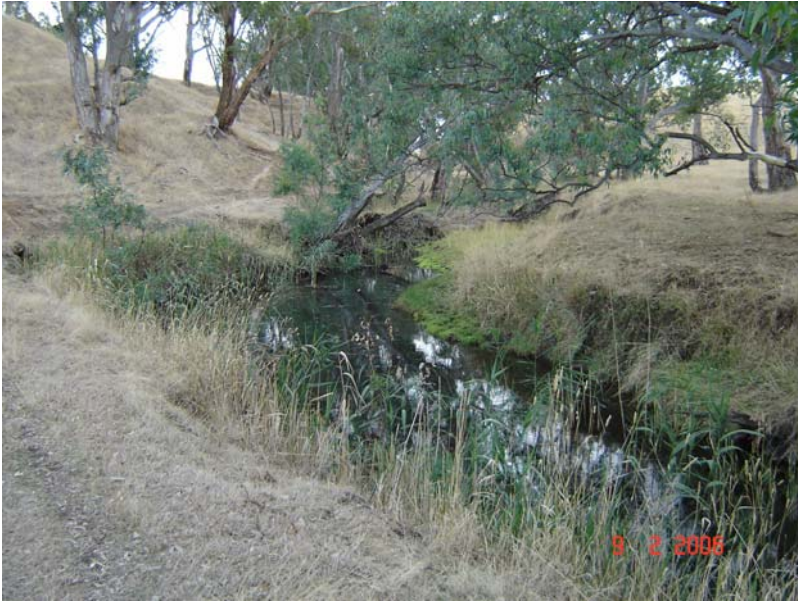
There is a distinct change in channel cross sectional area either side of the choke whereby the downstream channel capacity (refer to Figure 3) is four to five times the capacity of the channel at the upper end of the choke (refer to Figure 2). It is clear that the channel deepening and incision from the downstream reach is in the process of migrating upstream and resistance is being provided by the rock controls at the valley choke. The extent of erosion and resultant channel enlargement is also evident under the Eversley-Crowlands Road Bridge which has recently undergone structural upgrade works to the abutment piers which were being undermined. A deep scour pool exists at the downstream end of the choke which coincides with a sudden change in bed grade.

Figure 2. Typical channel dimension upstream of the second valley choke.

The observed incision and associated wearing of the rock bars at the second choke is a major concern. Failure of this choke has the potential to undermine all upstream values. A detailed investigation is required to determine the extent and rate of change occurring at the site. It will be necessary to conduct detailed assessment of the hydrologic, geomorphic and geologic features. A detailed survey of the site will also be required to obtain sufficient data to facilitate hydraulic modelling, under a variety of flow scenarios to help quantify key assessment parameters such as stream powers, flow rates, velocities, extent of bedrock, and the likely rate of change in stream morphology. This type of assessment will enable informed decisions to be made in relation to remedial actions that may be required to help secure the site.

Subject to the results of future investigations, it is conceivable that intervention will be required to help secure the integrity of this vulnerable choke at a mid or upper location. Remedial actions may include the construction of a highly resistive cut-off wall and/or grade control to reinforce the resistance of the choke against headward erosion and prevent the channel from enlarging or incising further.

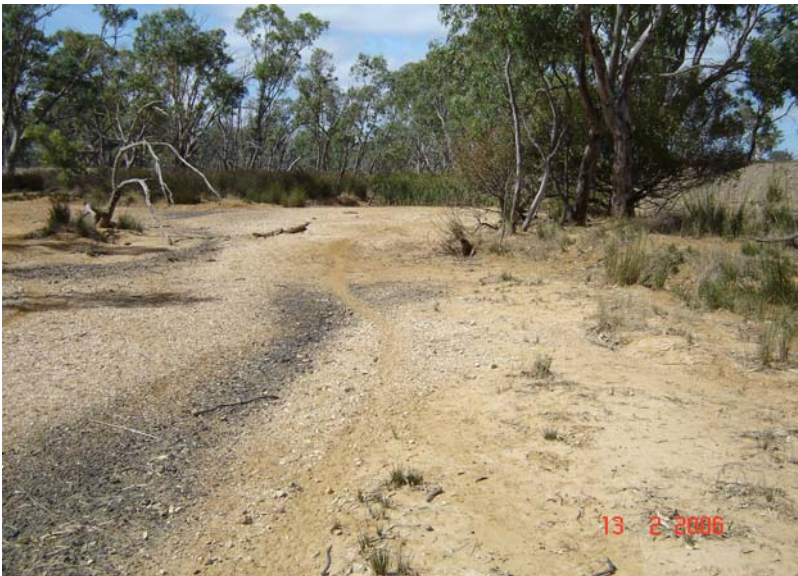
Figure 3. Typical channel dimension downstream of the second valley choke.

Some of the shale and slate rock controls appear to be incising through the choke section which indicates that headward erosion is migrating upstream. This segment at the lower end of the choke and valley constriction was also subject to a channel avulsion in a major flood in 1974.

The relatively high resistance of the rock bars in this choke compared to that of the surrounding alluvial plain segments is evident and has slowed the advancing headward erosion processes. However, erosion caused by historical and ongoing disturbances to the catchment together with changed flow regimes are threatening the integrity of this choke. The imminent loss of the bed control provided by the rock bars is threatening to severely alter the high value ecosystem and habitats that exist upstream.
